ILA-USMX JOINT SAFETY COMMITTEE

OSH Circular 2018-03 (15 March 2018)

Suspended [Overhead] Loads

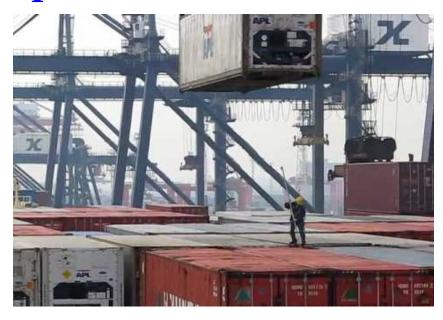
As the photo above suggests, in the unlikely (but certainly possible) event of the container passing over the head of the lasher becoming a free-falling object... the worker wouldn't have much of a chance for survival. Moreover, falling semi-automatic twistlocks have occurred more times in the past than we care to remember. For obvious reasons, we urge you to not get hit by one!

Plan, manage and conduct operations in a way that avoids these overhead hazards.
