MARINE SAFETY ALERT

Safety Alert 06-20

RECOGNIZING FIRE HAZARDS & PROPER CARGO STOWAGE ON RO-RO VESSELS

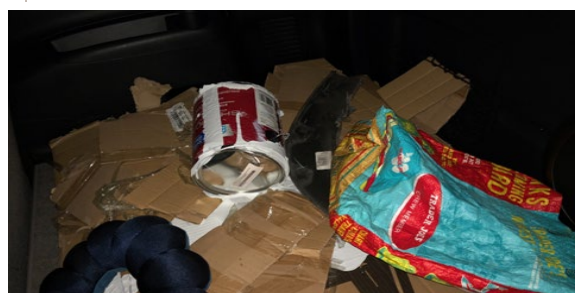
Paint and cardboard in a vehicle on deck 5 of cargo ship, taken in June 2020, provided by the Coast Guard.

- Protect vehicle batteries against short circuiting, for example by disconnecting the battery if appropriate;
- Remove all personal and combustible material from vehicles prior to loading them onto a vessel;
- Inspect and remove leaking vehicles from the vessel prior to sailing and do not permit vehicles known to be leaking to be loaded onto the vessel;
- Verify receiving guidelines of shippers and charterers are in alignment with the IMDG Code to include fuel levels prior to loading.
